# Manhole Inspection Summary

Manhole # S17S\_\_008MH

**Location** Address: **1500 CARROLL PARK**

Cross Street: **GWYNNS FALLS TRAIL**

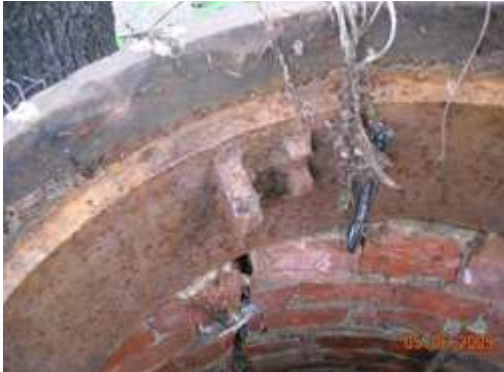
Miscellaneous

BOLT BAR SUPPORT DETERIORATED

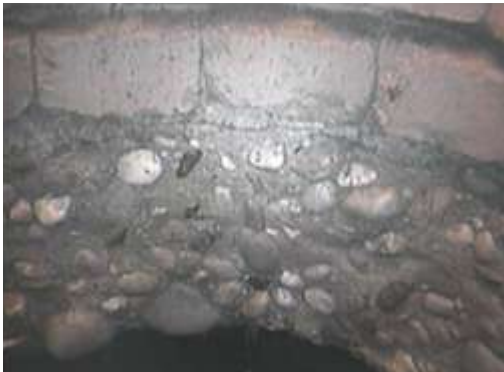
Defect 10

DETERIORATED CONCRETE  
TRANSITION BETWEEN CORBEL AND  
BARREL

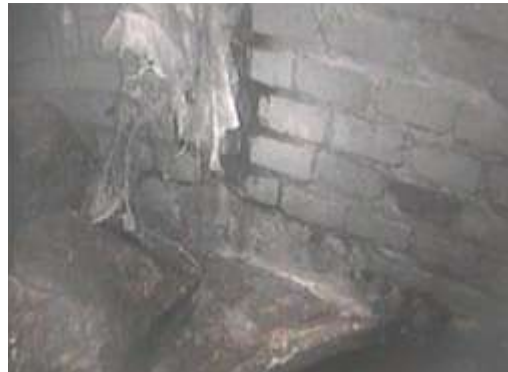
Defect 9

INFILTRATION @ CORBEL WALL

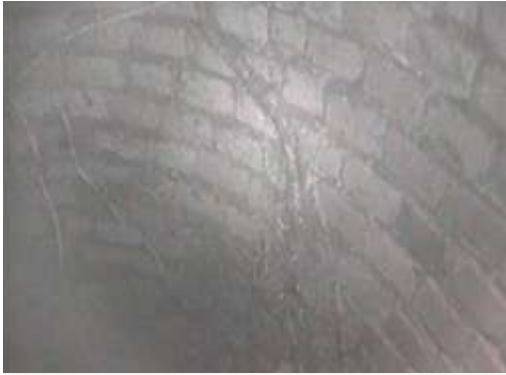
Defect 8

ROOT INTRUSION-TAP ROOT @  
BARREL WALL

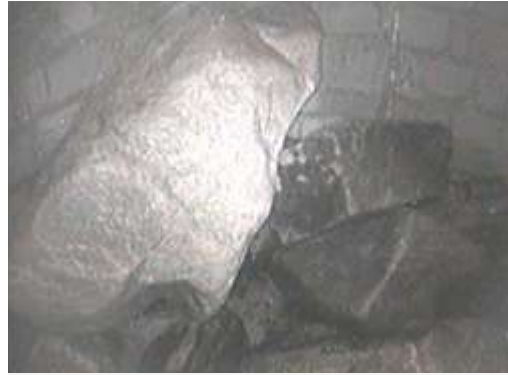
Defect 7

DEBRIS/BOULDERS ON BENCH

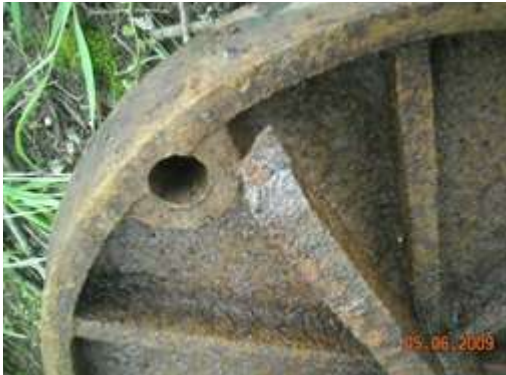
Defect 6

WORN COVER BOLT BAR

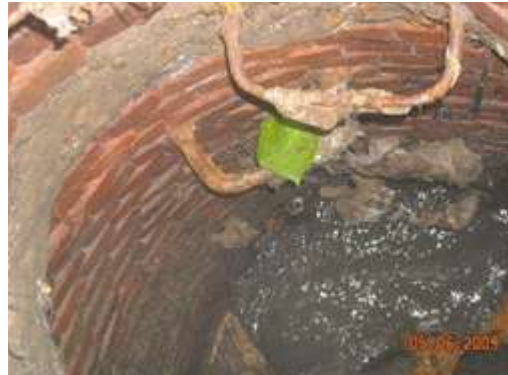
Defect 5

SURCHARGE EVIDENCE ON STEPS

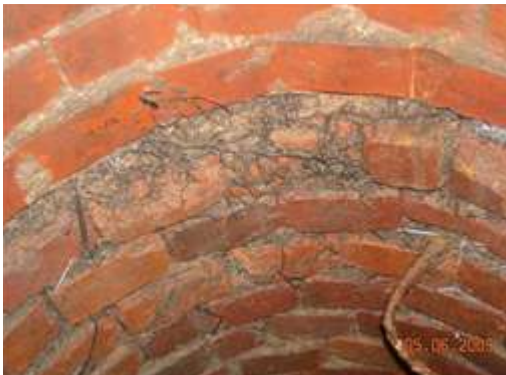
Defect 4

ROOT INTRUSION @ CORBEL WALL

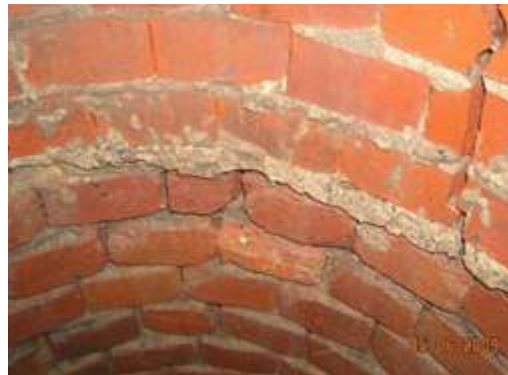
Defect 3

DETERIORATED CORBEL BRICKS

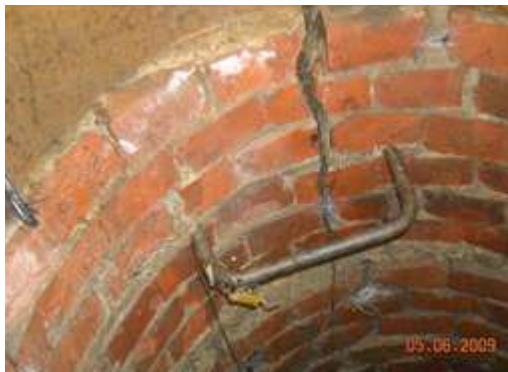
Defect 2

CRACKED CORBEL BRICKS

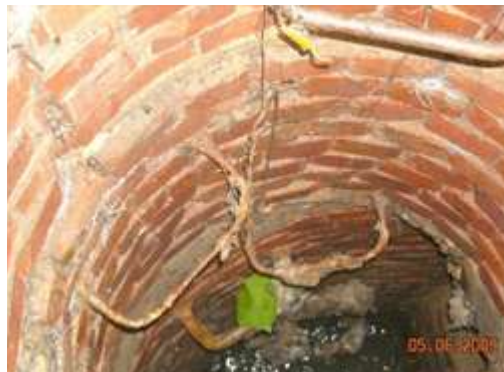
Defect 1

CORRODED STEPS

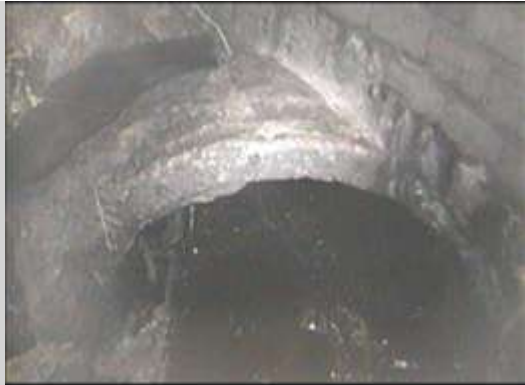
12 O'Clock Outflow

Pipe Height: **27.6** (in.) Rod and Bar (Angled)  
Pipe Material: **Clay** ☐ Pipe Lined  
Invert Depth: **13.00** (ft.) Flow Characteristics: **Turbulent**  
Deposits: ☐ None ☐ Mud ☒ **Sludge** ☒ **Debris** ☐ Grease  
Silt Depth: **3** (in.) Deposits Extent: **Light**  
Infiltration: **Weeper** Pipe Seal Cond: **Sound**

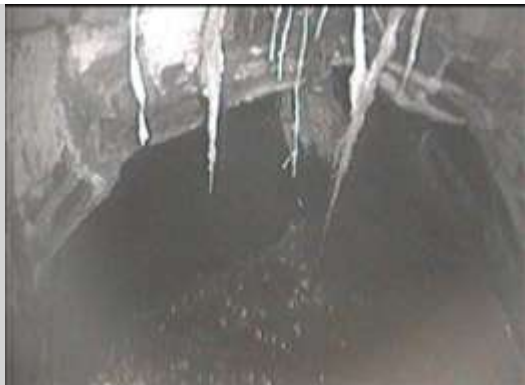
5 O'Clock Inflow

Pipe Height: **27.6** (in.) Rod and Bar (Angled)  
Pipe Material: **Clay** ☐ Pipe Lined  
Invert Depth: **12.85** (ft.) Flow Characteristics: **Turbulent**  
Deposits: ☒ **None** ☐ Mud ☐ Sludge ☐ Debris ☐ Grease  
Silt Depth: **0** (in.) Deposits Extent:  
Infiltration: **Evidence** Pipe Seal Cond: **Unknown**

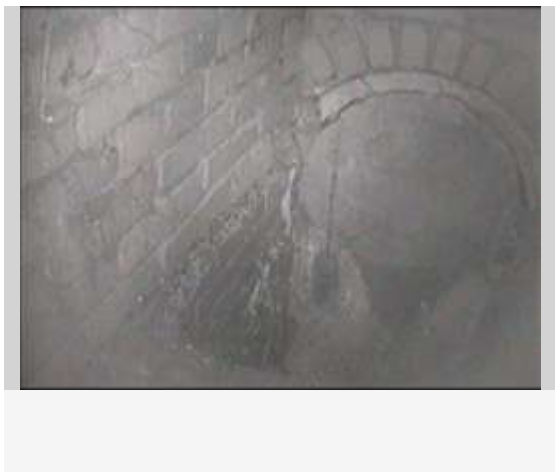
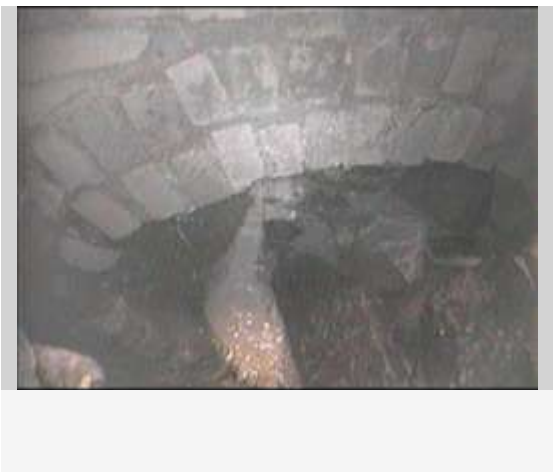
7 O'Clock Inflow

Pipe Height: 0 (in.)  
Pipe Material: ☐ Pipe Lined  
Invert Depth: 0.00 (ft.) Flow Characteristics: None  
Deposits: ☒ None ☐ Mud ☐ Sludge ☐ Debris ☐ Grease  
Silt Depth: 0 (in.) Deposits Extent:  
Infiltration: None Pipe Seal Cond: Cracked

Connects To: Stub connection / abandoned  
☐ Possible Illicit Connection
